RESULTS AND RECOMMENDATIONS

JANUARY 2024

ELLENBURG STREET TREE INVENTORY

ELLENBURG | WASHINGTON

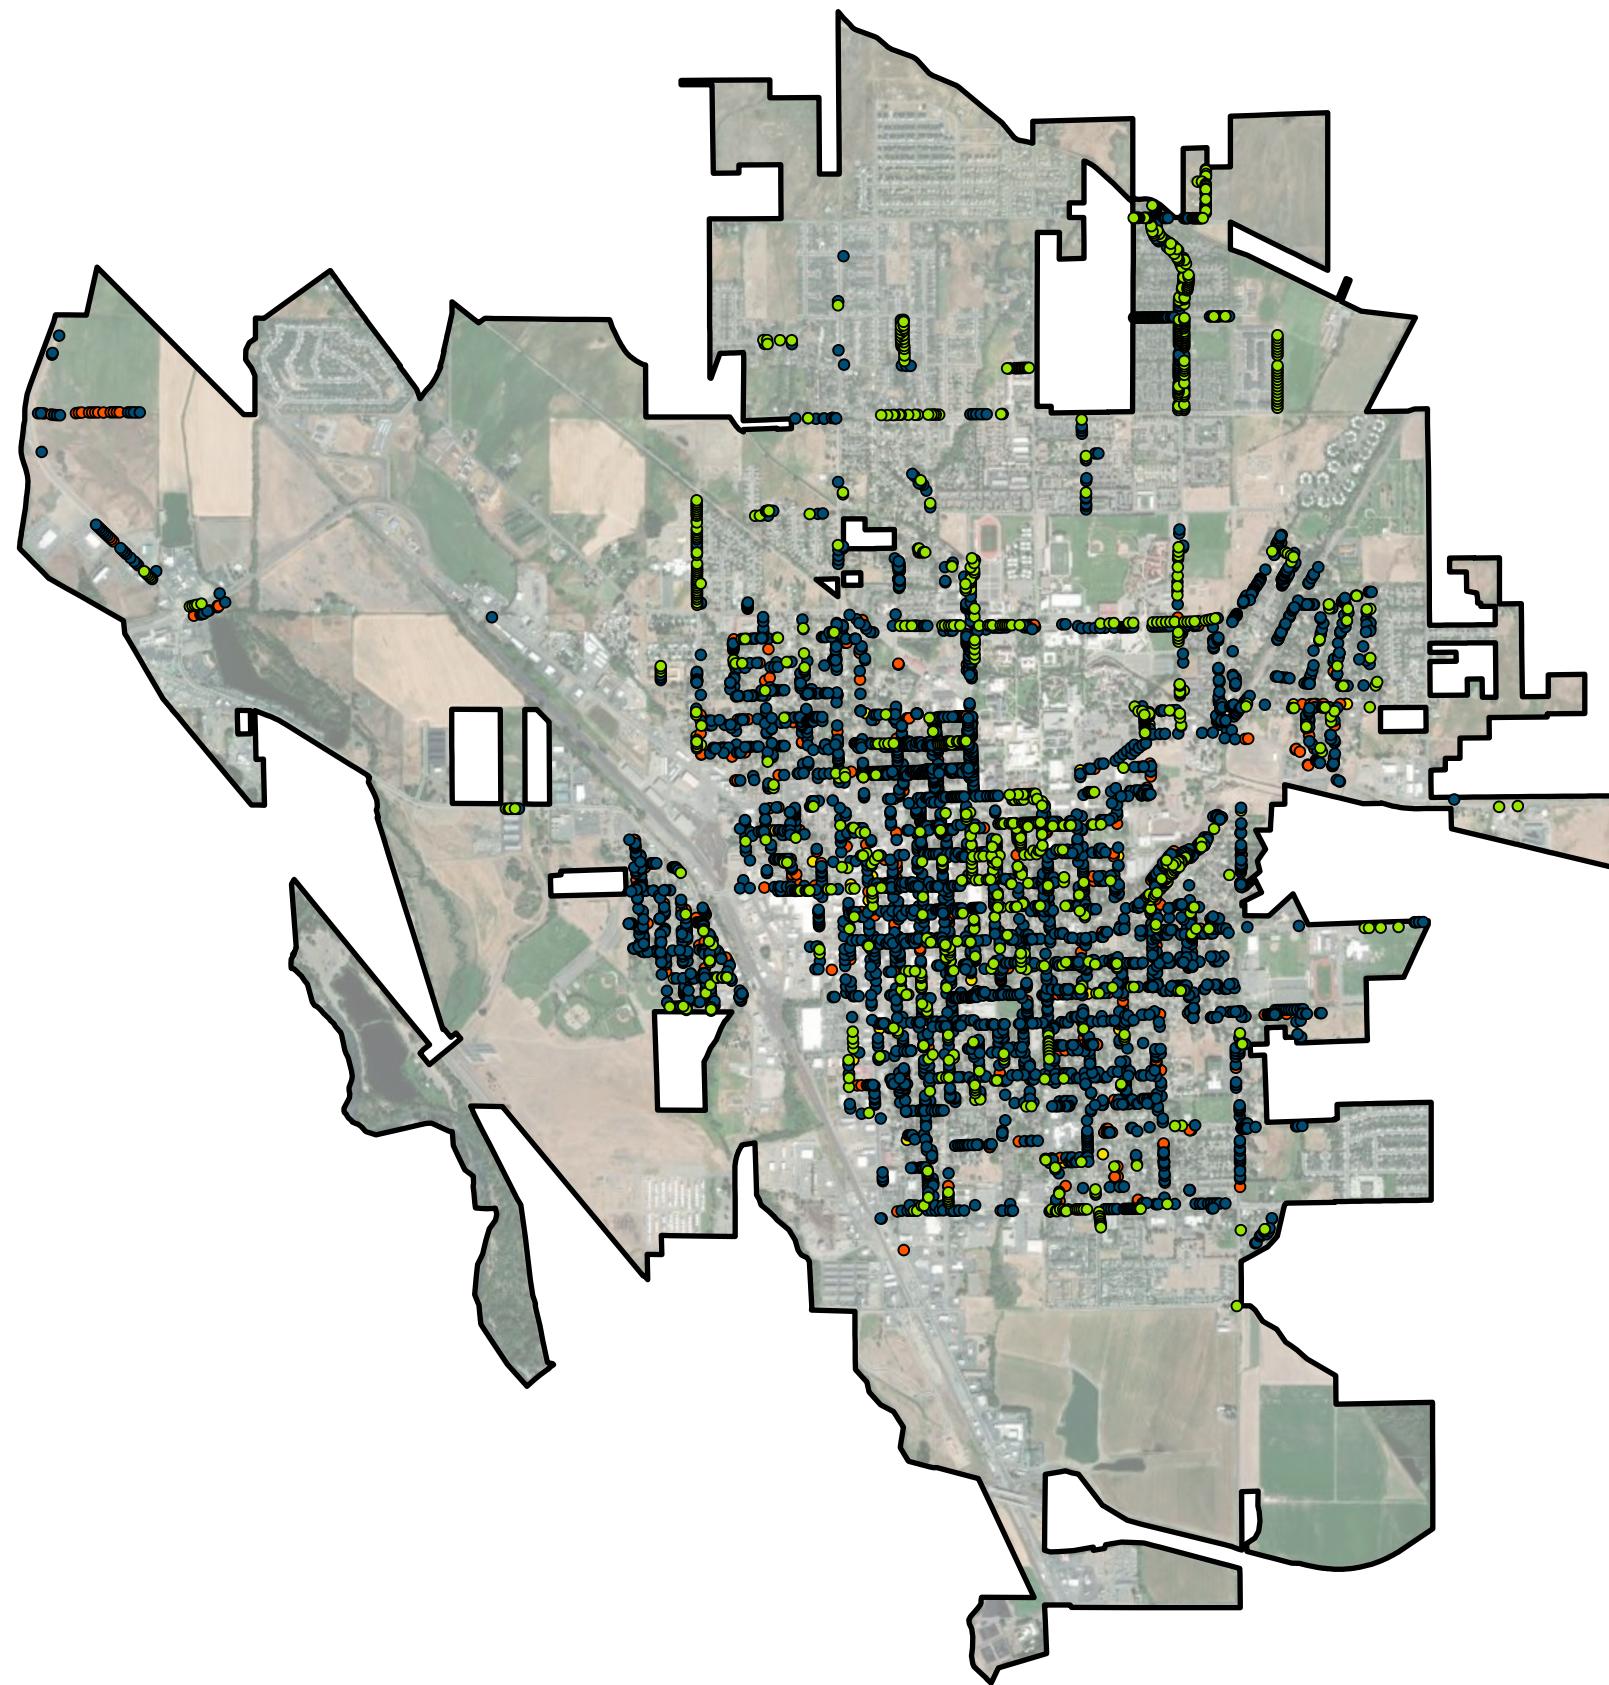
Map - Condition

According to the condition determination table (Table 1), the majority of trees are in *Good* condition (see Figure 2 below). Newly planted trees are establishing well, and generally appear to be in good health with proper structure. There are several concentrated areas with trees in *Excellent* condition, notably in a newly developed area along N Alder St., N Cora St., Dean Nicholson Blvd., the streets surrounding City Hall, and Reed Park.

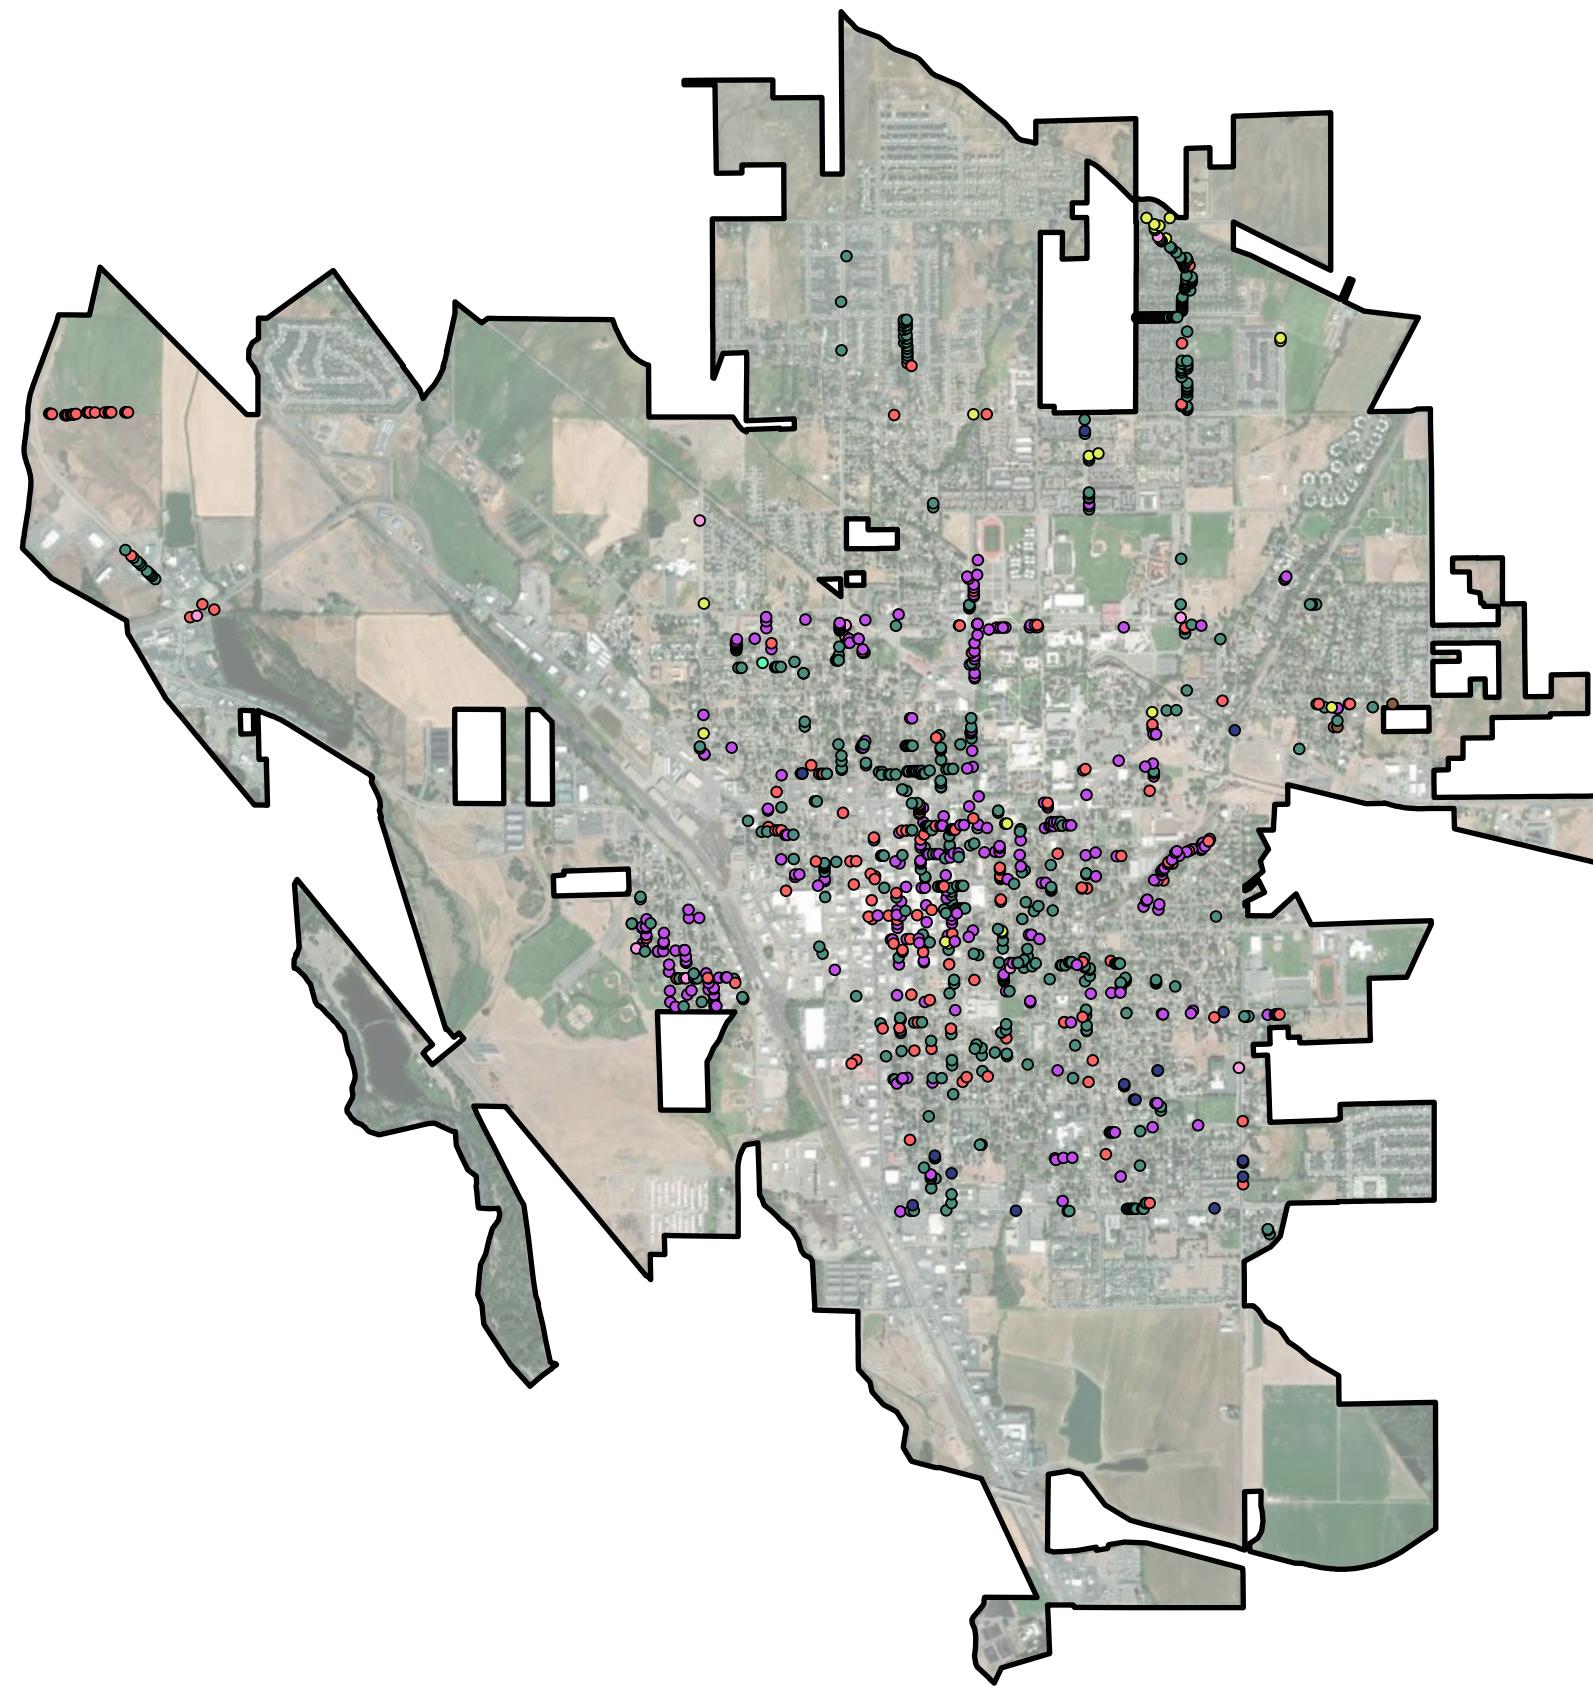
Map - Maintenance Recommendations

Many locations inventoried (5,435 points) are noted as needing no maintenance. A total of 1,028 trees currently require some level of maintenance. Specific recommendation types are noted in Table 4. The most common type of recommended maintenance is Raise Canopy/Clearance Prune with a total of 452 trees identified for this category of maintenance.

Street trees range in age from newly planted to mature. Structural pruning is critical for young trees as they mature. This practice provides the greatest possible longevity and reduces pruning and structural flaws in the future. Structural pruning recommendations include removing codominant trunks, training a single leader, and properly raising the canopy over the street and sidewalk as the tree ages.

Upright and columnar trees generally grow with clustered branching instead of a single main leader, such as *Acer rubrum* cultivars. The mature canopies of these trees often contain codominant trunks and included bark, which are structural flaws and increase the chance of major branch failure. Many of the assessed trees with codominant trunks and included bark are too mature to feasibly correct canopy structure by removing one of the leaders. Such trees should be monitored for cracking in their narrow branch unions, pruned to reduce the weight at the end of the branches, and have deadwood removed when visible. When upright and columnar species are planted in the future, frequent structural pruning will encourage proper branch spacing and mitigate codominant stems and included bark.

Of the 183 trees recommended for removal, the species most recommended for this maintenance is black tupelo (*Nyssa Sylvatica*), with a total of 19 out of 25 (76%) recommended for removal. This is a very large percentage compared to the next highest species recommended for removal, with red maple (*Acer rubrum*) having 14 trees recommended for removal out of 361 (3.9%). Therefore, black tupelo is not recommended for continued planting as a street tree.

Of the 323 trees recommended for deadwood removal, the top five species recommended for this category of maintenance are Siberian Elm (*Ulmus pumila*) with 73 out of 395 (18.5%), Norway maple (*Acer platanoides*) with 45 out of 451 (10%), honey locust (*Gleditsia triacanthos*) with 27 out of 236 (11.4%), black locust (*Robinia pseudoacacia*) with 22 out of 137 (16%), and blue spruce (*Picea pungens*) with 15 out of 314 (4.7%). These tree species represent several of the largest species identified in the inventory and deadwood accumulation in mature trees is to be expected and not necessarily an indication of poor health.
