1 CHAPTER 4. KITTITAS VALLEY

2 This chapter describes the conditions within the shoreline inventory area of the
3 Kittitas Valley (including the City of Ellensburg). Kittitas Valley shorelines include
4 the Yakima River and its tributaries between the Taneum Creek confluence and the
5 Wilson Creek confluence (Figure 4-1). The 11 streams and 7 lakes and ponds within
6 the Kittitas Valley are described in terms of their physical characteristics, ecological
7 conditions, and human environment/land use characteristics. Readers are
8 encouraged to review Chapter 2 and the maps in Appendix A for additional context
9 on the information presented here.

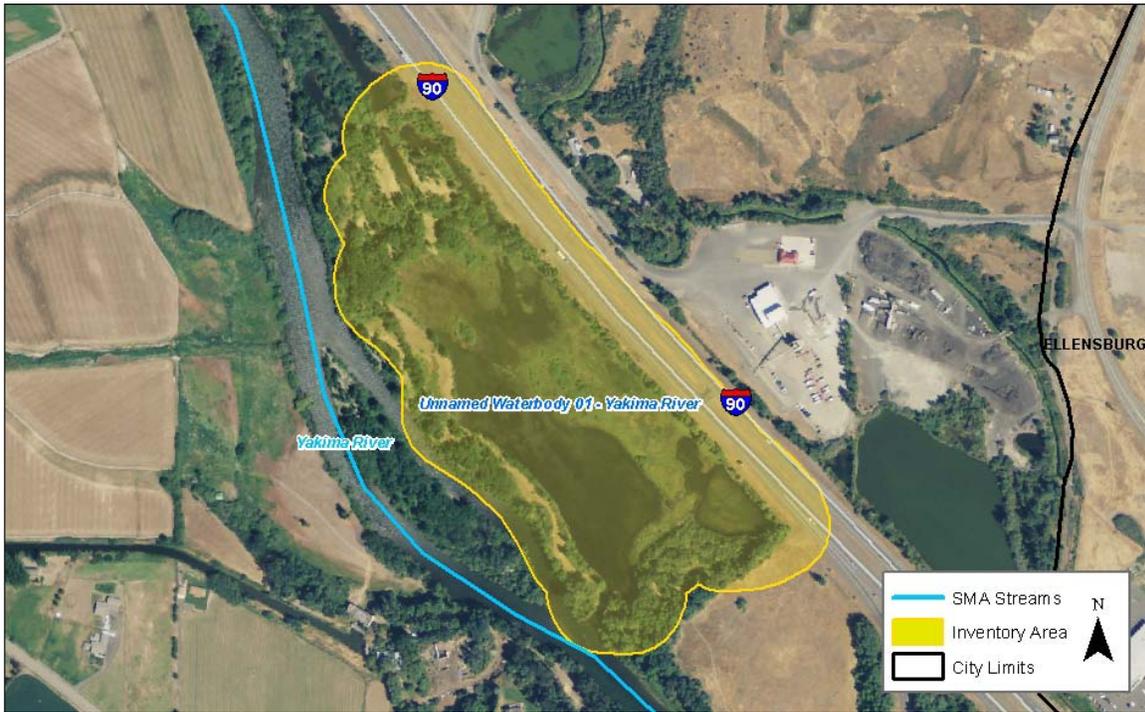
More than half of the reach area (58%) is located within the FEMA 100-year floodplain. No landslide hazard areas are mapped within the reach.
