**AIRPORT ROAD RESIDENTIAL DEVELOPMENT
ELLENSBURG, WASHINGTON**

*November 3, 2025
Project No: 25-438*

**RE: GEOTECHNICAL ENGINEERING STUDY; PROPOSED AIRPORT ROAD
RESIDENTIAL DEVELOPMENT; ELLENSBURG, WASHINGTON**

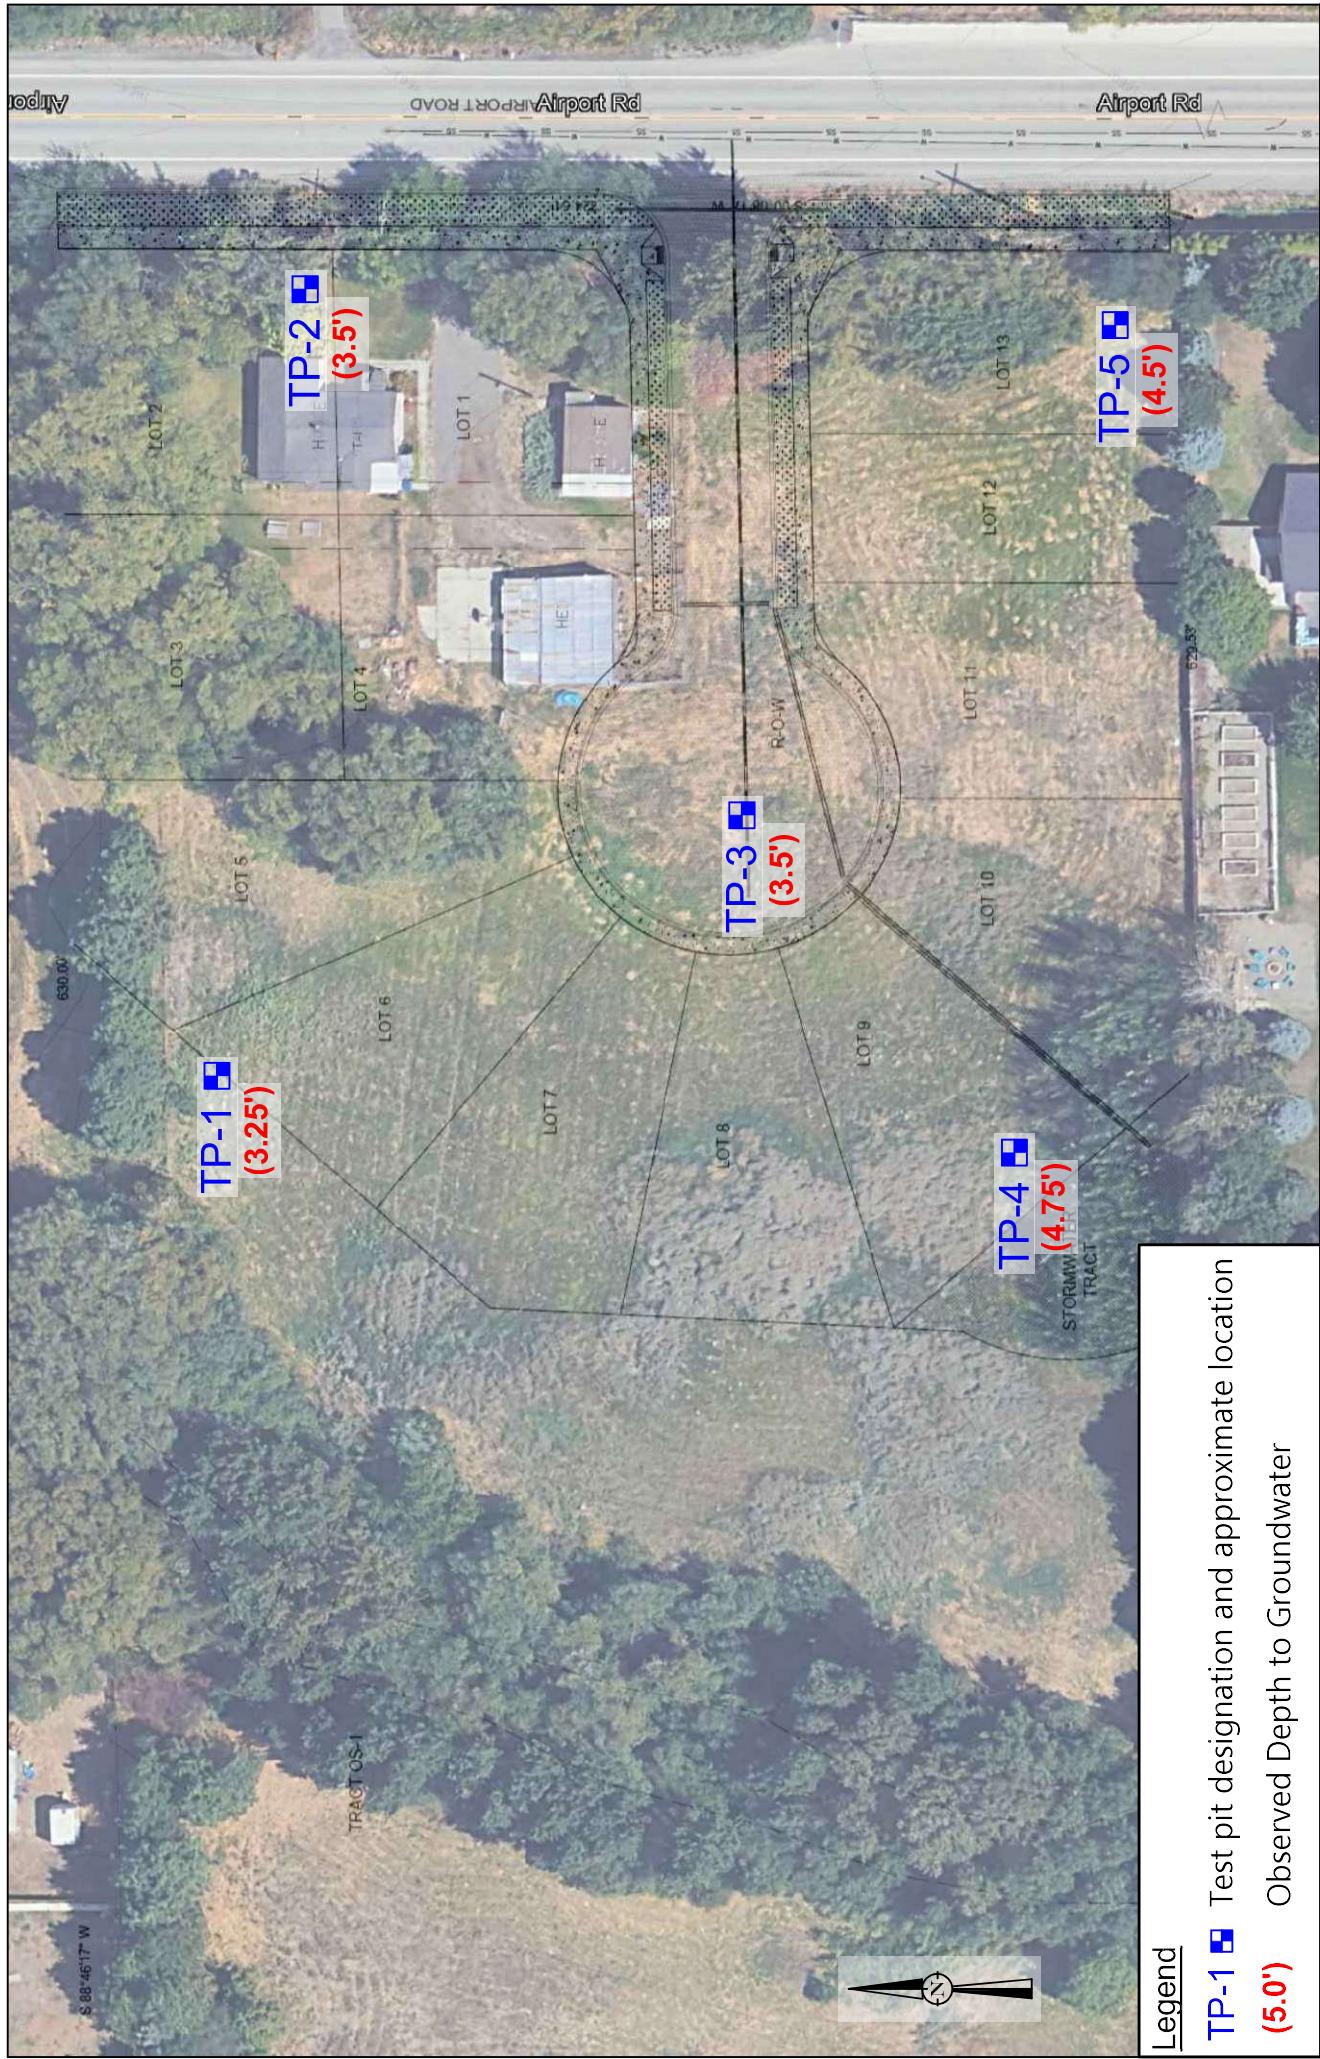
Airport Road	Residential Development
	Ellensburg, Washington
	Site Layout & Exploration Plan
25-438	FIG. 2

The exploration plan consisted of excavating five test pits designated TP-1 through TP-5 (**Figure 2 – Site Layout & Exploration Plan**). L-Boz Construction (L-Boz) excavated the test pits on October 10, 2025, using a CAT 314C excavator equipped with an 18-inch-wide bucket. Infiltration testing was performed in TP-4, near the proposed stormwater tract.

The subsurface conditions are known only at the test pit locations on the date explored and should be considered approximate. Actual subsurface conditions may vary between excavation locations. The test pit locations are presented in **Figure 2** and the test pit logs are presented in **Appendix A**. Our geologist classified the in-situ soil in the field and transported the soil samples to the laboratory for further examination and testing.

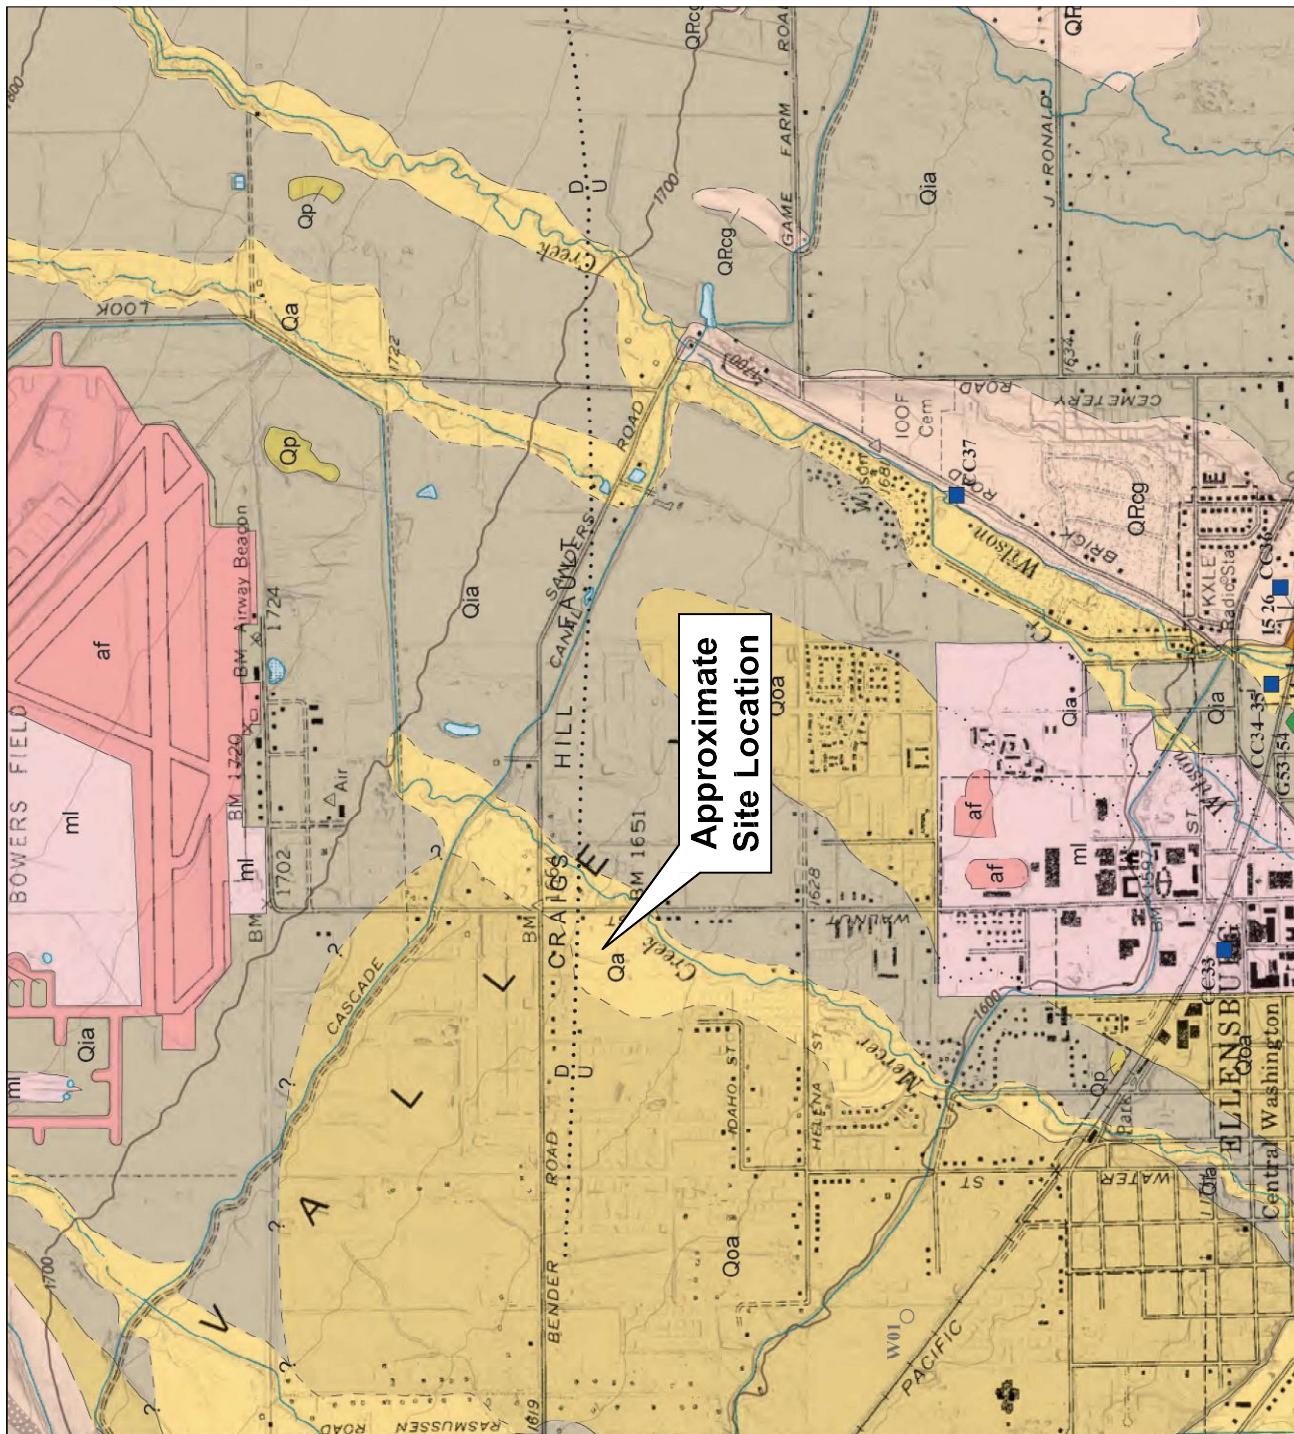
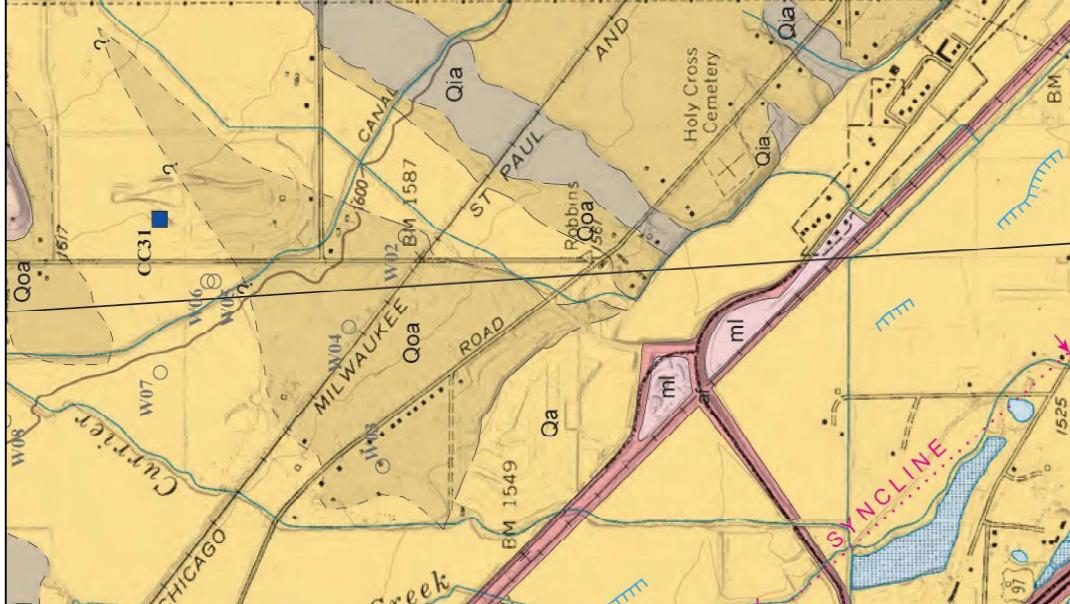
Near Surface Geology
25-438 FIG. 3

Near Surface Geology map developed using the Geologic Map of the Ellensburg North and Southern Half of the Reecer Canyon 7.5-Minute Quadrangles, Kittitas County, Washington; Washington Geological Survey, Map Series 2000-01.

Groundwater was encountered at approximately 3.25 to 4.75 feet bgs throughout the site (**Figure 3**). We observed rusty mottling coloration at approximately 2.5 to 3.5 feet. Mottling in soils is defined as having irregular spots of assorted colors that vary in number and size. Orange or rusty mottling is a potential indicator of seasonal high groundwater elevations. Groundwater in this area is heavily influenced by local irrigation and Mercer Creek, located approximately 200 feet east of the site. Groundwater levels are generally at their lowest during late winter and early spring before irrigation starts. We anticipate that groundwater is near the seasonal high due to the irrigation season ending approximately 8 weeks prior to our investigation. However, based on our experience of the area, we anticipate the seasonal high groundwater levels may reach the observed rust mottling.

Based on our review of available geologic literature, Craigs Hill Fault, a hidden, west-east trending high-angle dip-slip fault is located along the north edge of the site (**Figure 3**). A hidden thrust fault complex of similar orientation is also located along Manastash Ridge, approximately 4.4 miles to the southwest. We are not aware of any demonstrated movement along these faults in the last 10,000 years. We did not observe any evidence of surface rupture or recent faulting during our field observation. Therefore, we conclude the fault rupture potential is low at this site.

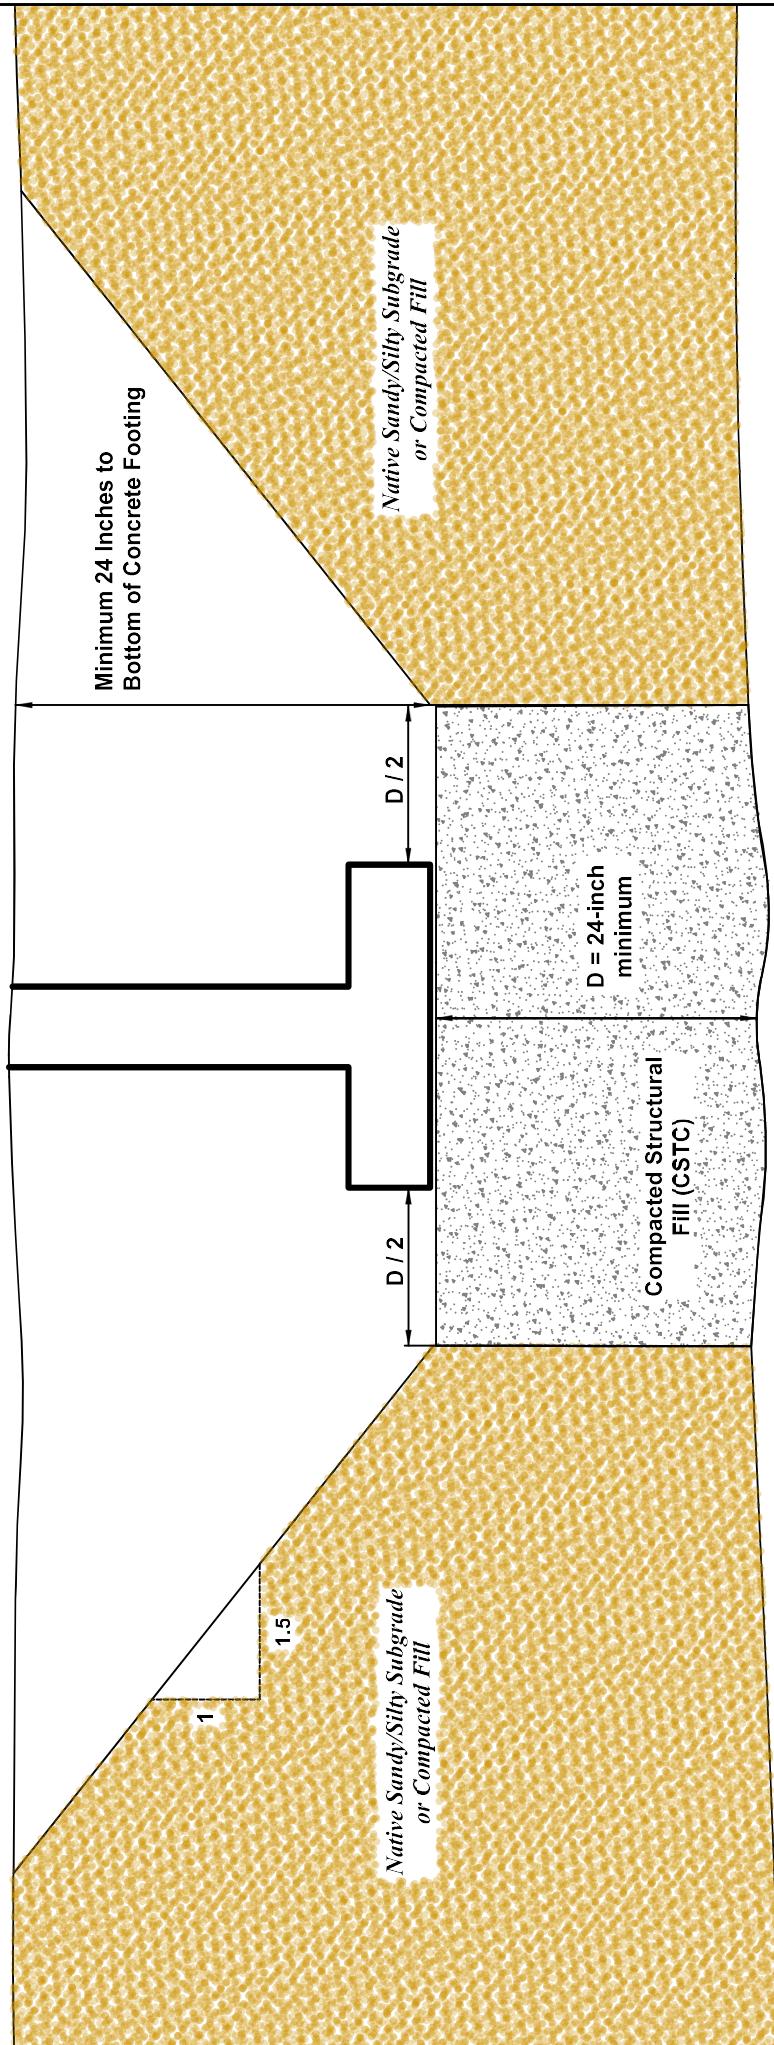
1. Over-excavate until gravelly soils are encountered (approx. 1.5 to 3 feet).
2. Compact the exposed subgrade to a firm and unyielding condition.
 - 2.1. The geotechnical engineer should observe prepared subgrade prior to structural fill placement.
3. Place structural fill (5/8 inch minus, CSTC) into the trench in 8-inch loose lifts and compact to 95% of ASTM D 1557.

The proposed structures may be supported on conventional spread or continuous footings bearing on the native soils, or compacted structural fill extending to properly prepared native subgrade. Exterior footings should be embedded a minimum 24 inches below adjacent grades for bearing considerations and frost protection. It is important that footings bear on consistent conditions to avoid differential settlement. We recommend over-excavating the footings to remove the silty sand and replacing the excavated material with $\frac{5}{8}$ -inch minus CTC compacted to 95 percent of ASTM D 1557. Footing backfill should be placed as shown in **Figure 4 – Footing Over-Excavation and Backfill**.

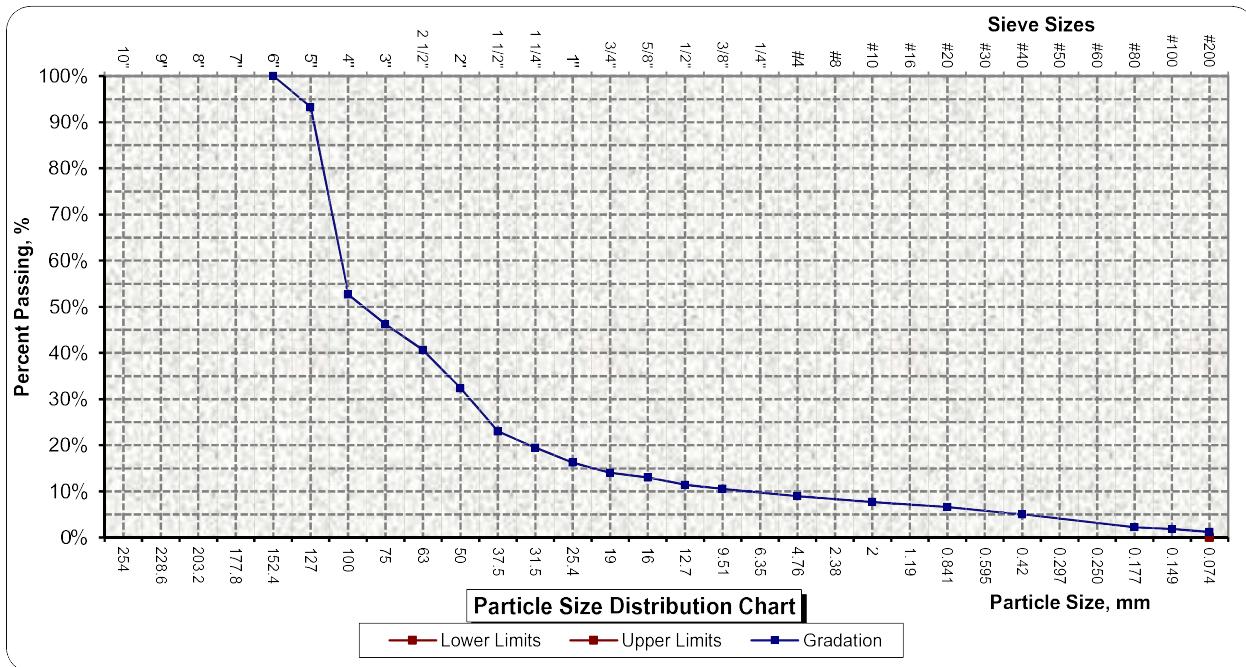
Sieve Size:	Percent Passing:	Specs:	Sieve Size:	Percent Passing:	Specs:	Sieve Size:	Percent Passing:	Specs:
10" (254mm)			1 1/2" (37.5mm)	23%		#10 (2mm)	8%	
9" (228.6mm)			1 1/4" (31.5mm)	19%		#16 (1.19mm)		
8" (203.2mm)			1" (25.4mm)	16%		#20 (0.841mm)	7%	
7" (177.8mm)			3/4" (19mm)	14%		#30 (0.595mm)		
6" (152.4mm)	100%		5/8" (16mm)	13%		#40 (0.42mm)	5%	
5" (127mm)	93%		1/2" (12.7mm)	11%		#50 (0.297mm)		
4" (100mm)	53%		3/8" (9.5mm)	11%		#60 (0.250mm)		
3" (75mm)	46%		1/4" (6.35mm)			#80 (0.177mm)	2%	
2 1/2" (63mm)	41%		#4 (4.76mm)	9%		#100 (0.149mm)	2%	
2" (50mm)	32%		#8 (2.38mm)			#200 (0.074mm)	1.2%

CLIENT: Rebecca Houghton
PROJECT: Airport Road Residential Development
SAMPLE SOURCE: TP-5 @ 5'
DATE SAMPLED: 10/10/2025
MATERIAL TYPE: Poorly Graded Gravel (GP)

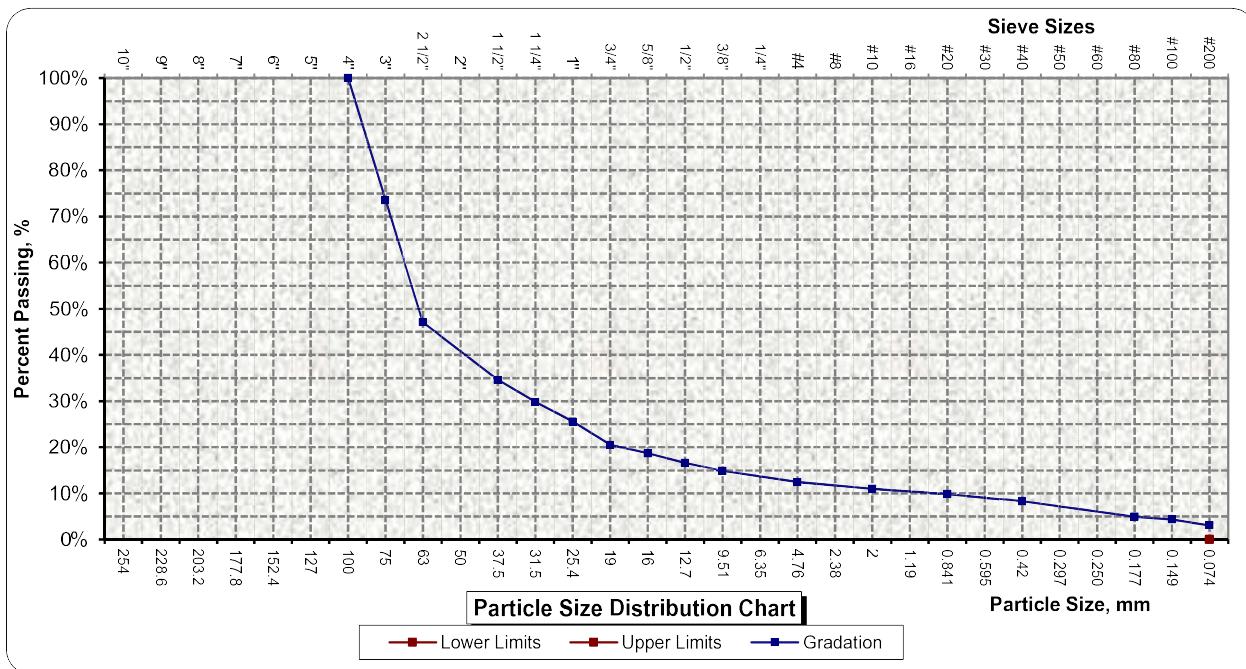
Sieve Size:	Percent Passing:	Specs:	Sieve Size:	Percent Passing:	Specs:	Sieve Size:	Percent Passing:	Specs:
10" (254mm)			1 1/2" (37.5mm)	35%		#10 (2mm)	11%	
9" (228.6mm)			1 1/4" (31.5mm)	30%		#16 (1.19mm)		
8" (203.2mm)			1" (25.4mm)	26%		#20 (0.841mm)	10%	
7" (177.8mm)			3/4" (19mm)	21%		#30 (0.595mm)		
6" (152.4mm)			5/8" (16mm)	19%		#40 (0.42mm)	8%	
5" (127mm)			1/2" (12.7mm)	17%		#50 (0.297mm)		
4" (100mm)	100%		3/8" (9.51mm)	15%		#60 (0.250mm)		
3" (75mm)	73%		1/4" (6.35mm)			#80 (0.177mm)	5%	
2 1/2" (63mm)	47%		#4 (4.76mm)	12%		#100 (0.149mm)	4%	
2" (50mm)			#8 (2.38mm)			#200 (0.074mm)	3.1%
