# Surf City Waterpark and Lodge, Ellensburg Critical Areas Report

*Prepared for*

Canyon Road Investors, LLC.  
PO Box 862  
605 E 4<sup>th</sup> Ave  
Ellensburg, WA 98926

April 2015

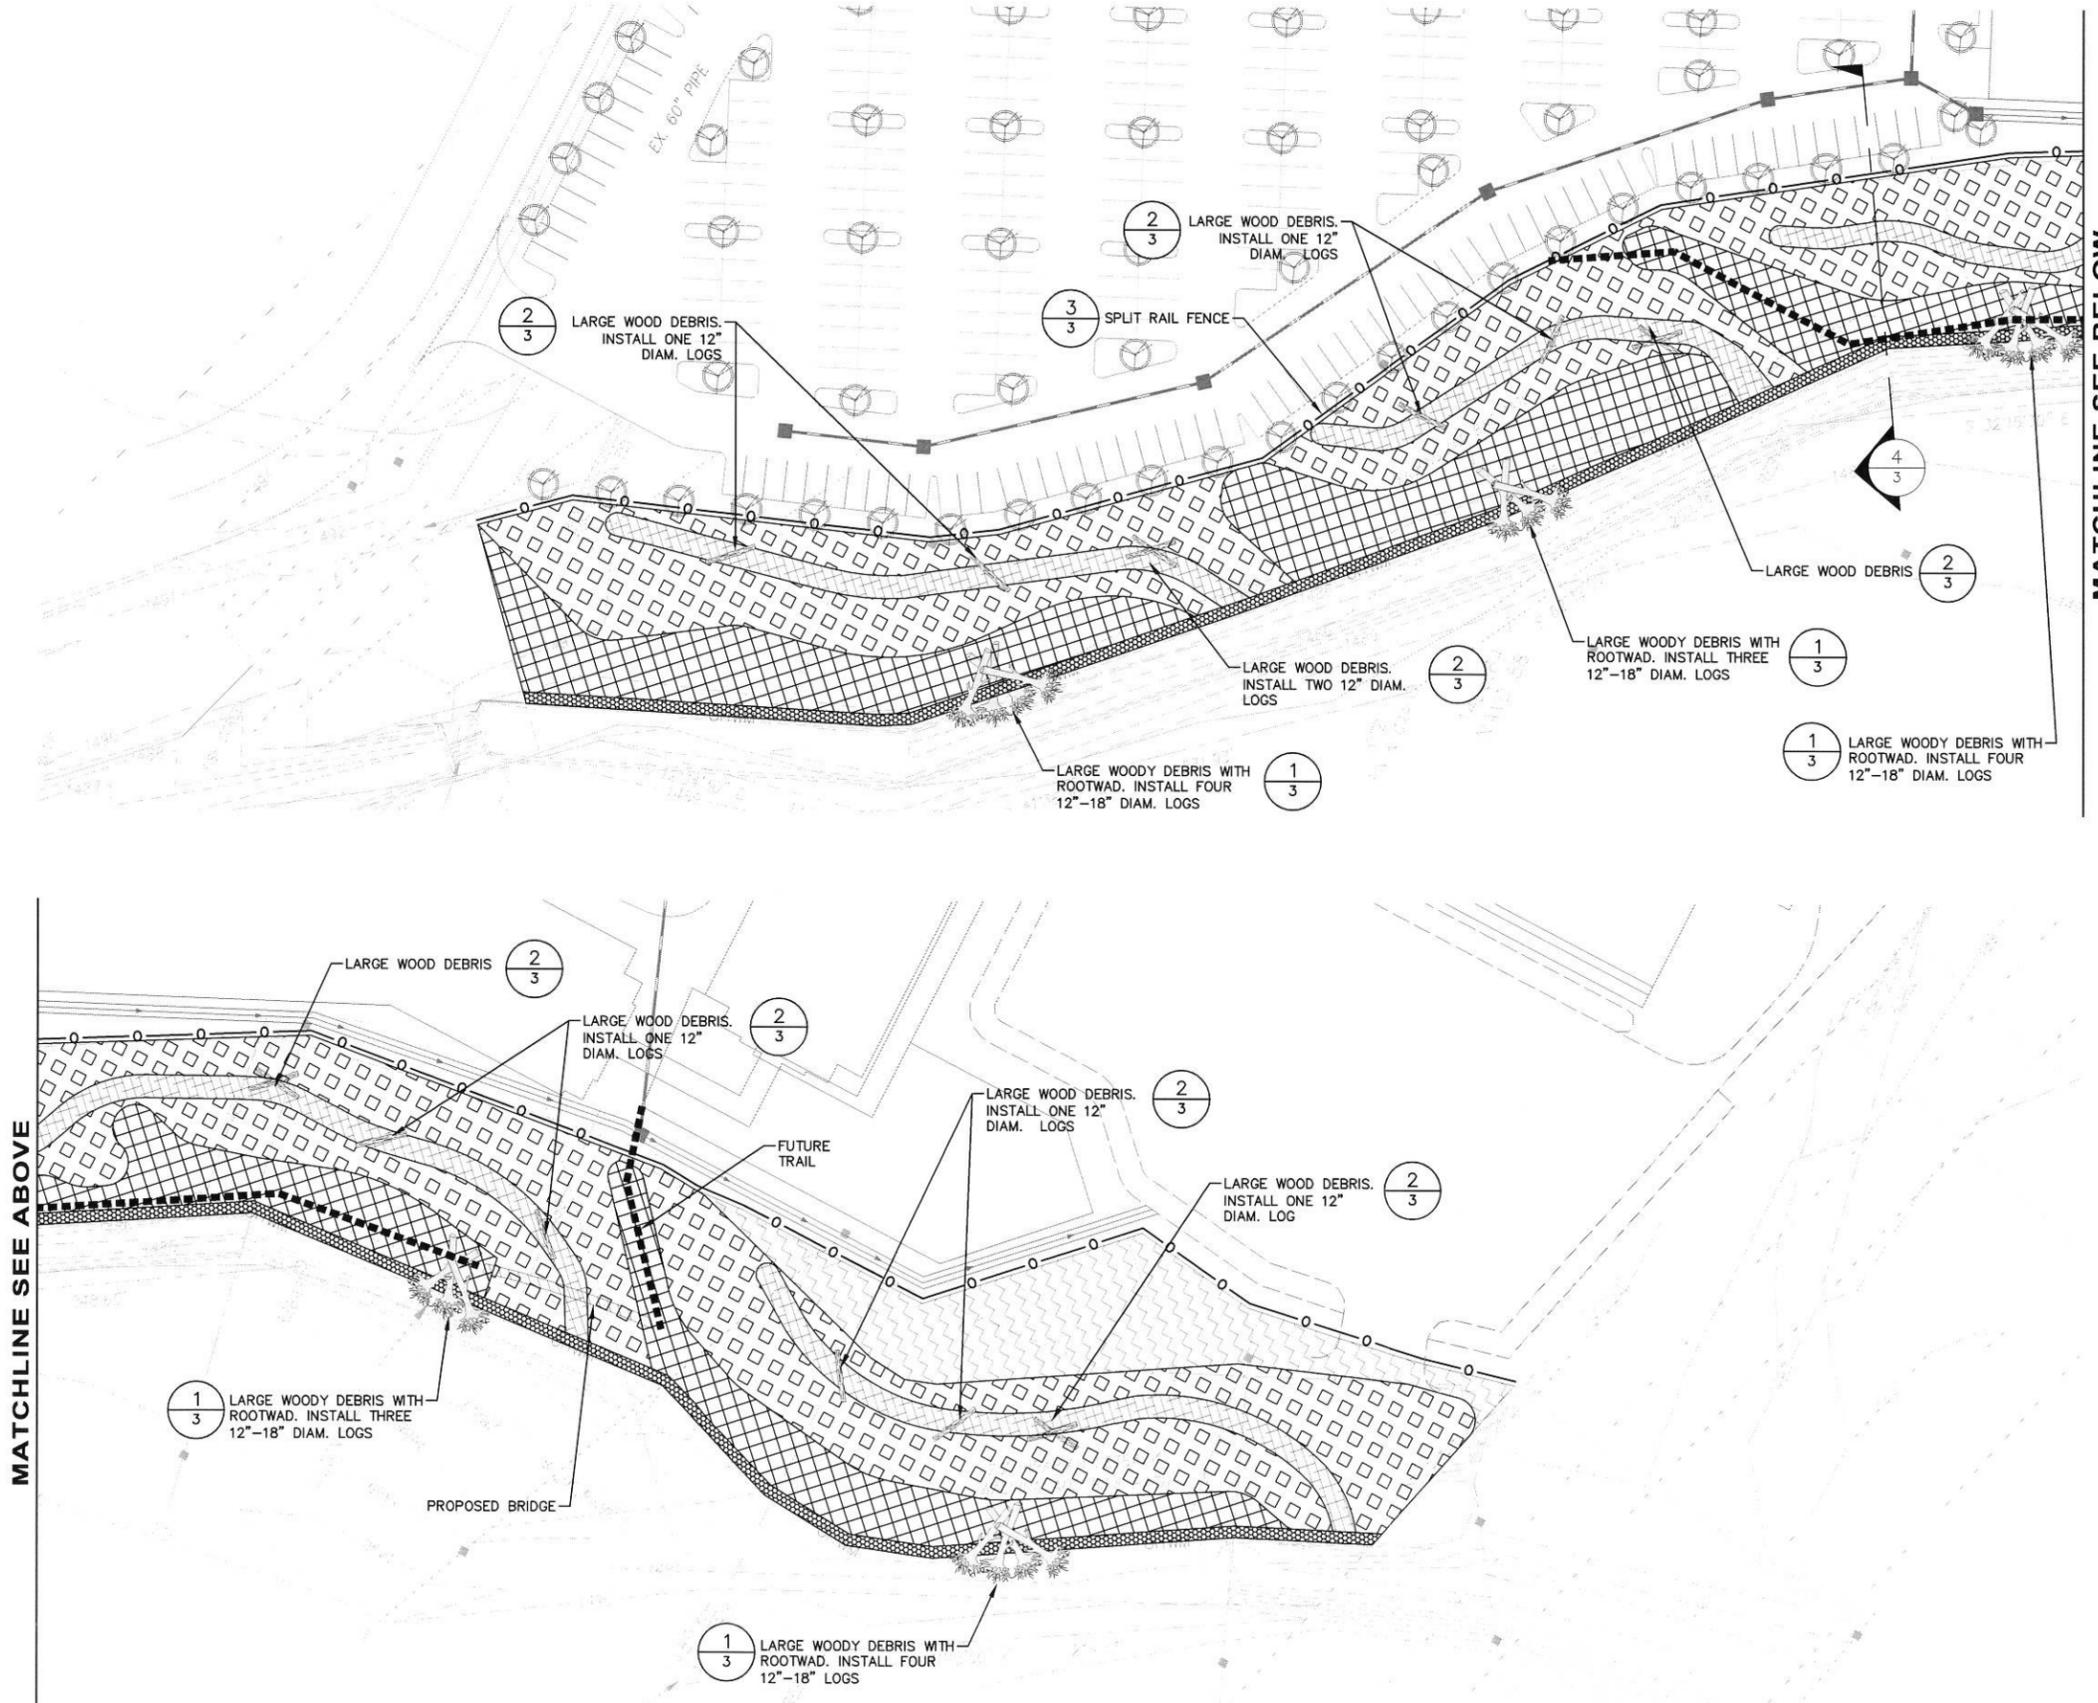
ZONE 1 = 32,395 SQ FT  
PLANT THE FOLLOWING TREES AND SHRUBS, SIZES AS NOTED AT 5' O.C. AS SHOWN:

ZONE 2 = 56,570 SQ FT  
PLANT THE FOLLOWING TREES AND SHRUBS, SIZES AS NOTED AT 5' O.C. AS SHOWN:

ZONE 3 = 6,728 SQ FT  
PLANT THE FOLLOWING TREES AND SHRUBS, SIZES AS NOTED AT 5' O.C. AS SHOWN:

ZONE 4 = 10,449 SQ FT  
PLANT THE FOLLOWING TREES AND SHRUBS, SIZES AS NOTED AT 5' O.C. AS SHOWN:

ZONE 5 = 12,468 SQ FT  
PLANT THE FOLLOWING TREES AND SHRUBS, SIZES AS NOTED AT 5' O.C. AS SHOWN:

The buffer will be graded to create four lower bench areas with “backwater channels” that connect to the ordinary high water mark of Wilson Creek (see Riparian Restoration Plan, Attachment B). These benches will act as floodplains during high water events in Wilson Creek. During normal flows, the channels (swales) will not contain standing water. During high flows in Wilson Creek, these swales will fill with overflowing water, providing refuge for fish.

Native plants will be established throughout the buffer. For planting purposes, the buffer has been divided into 5 zones. Trees and shrubs will also be planted in zones 1, 2, 3, and 4 (Table 1). Grass seed mix will be spread in zones 2 and 5 (Table 2).

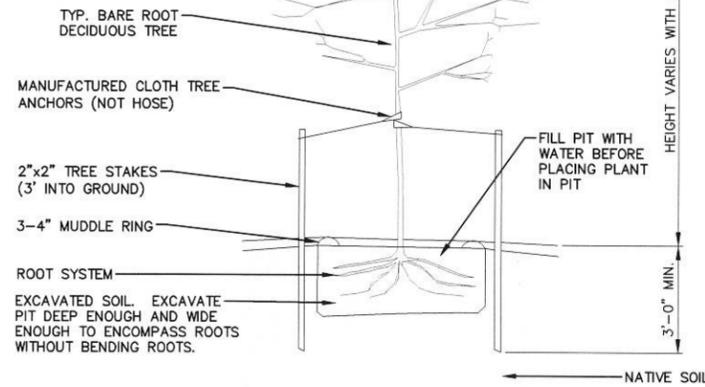
**DECIDUOUS AND EVERGREEN TREE PLANTING**  
N.T.S.

NOTE:  
ALL TREES OVER 1-1/4" DIAMETER  
ARE TO BE STAKED (2 PER TREE)

Twelve species of trees will be planted (1,000 individual plantings), as well as 12 species of shrubs (approximately 3,000 individual plantings). Plantings will be 5 feet apart, and staked if necessary. Planting details and plant spacing diagrams are shown on page 2 of the Riparian Restoration Plan.

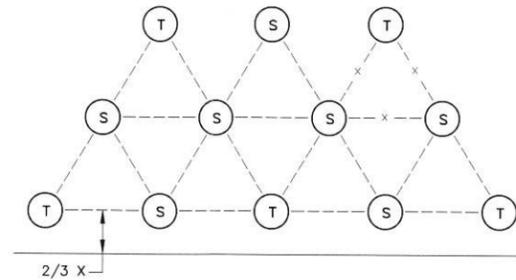
**TYPICAL PLANT SPACING**

NOTE:  
GROUP LIKE SHRUBS IN GROUPS OF 3 TO 5.  
TREES SHOULD NOT BE PLACED NEXT TO EACH OTHER.

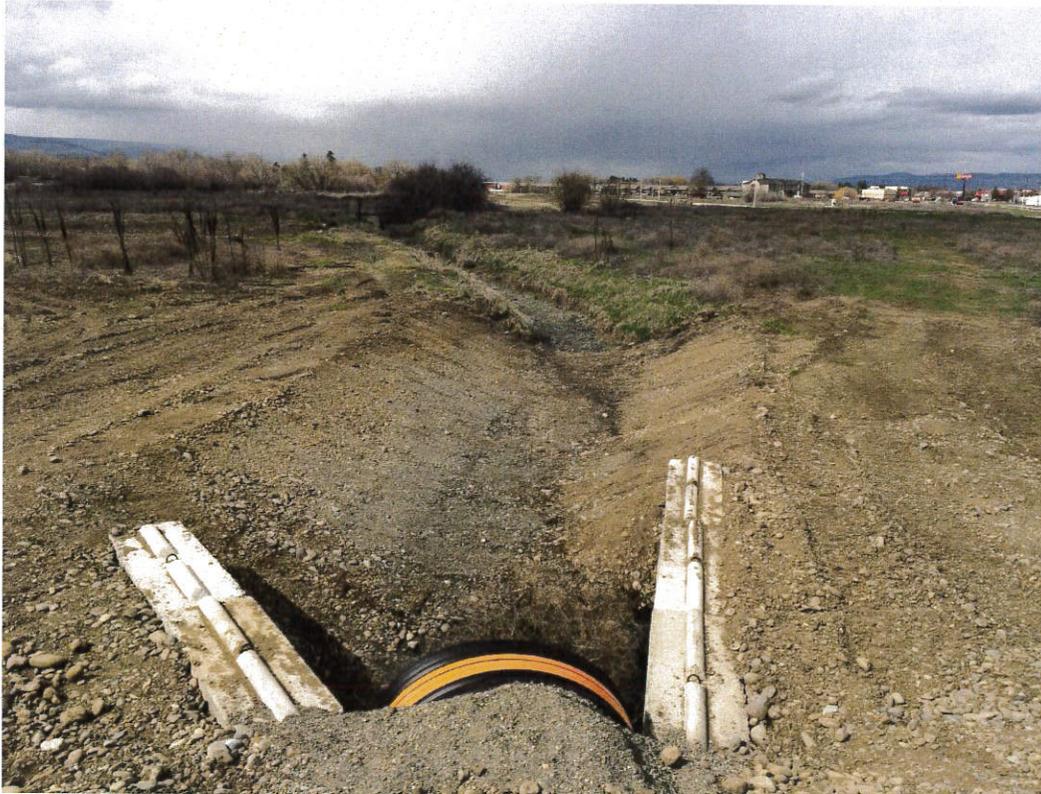
Photo 4. Bull Ditch, showing bare ground along banks in foreground, and reed canarygrass along banks in background.

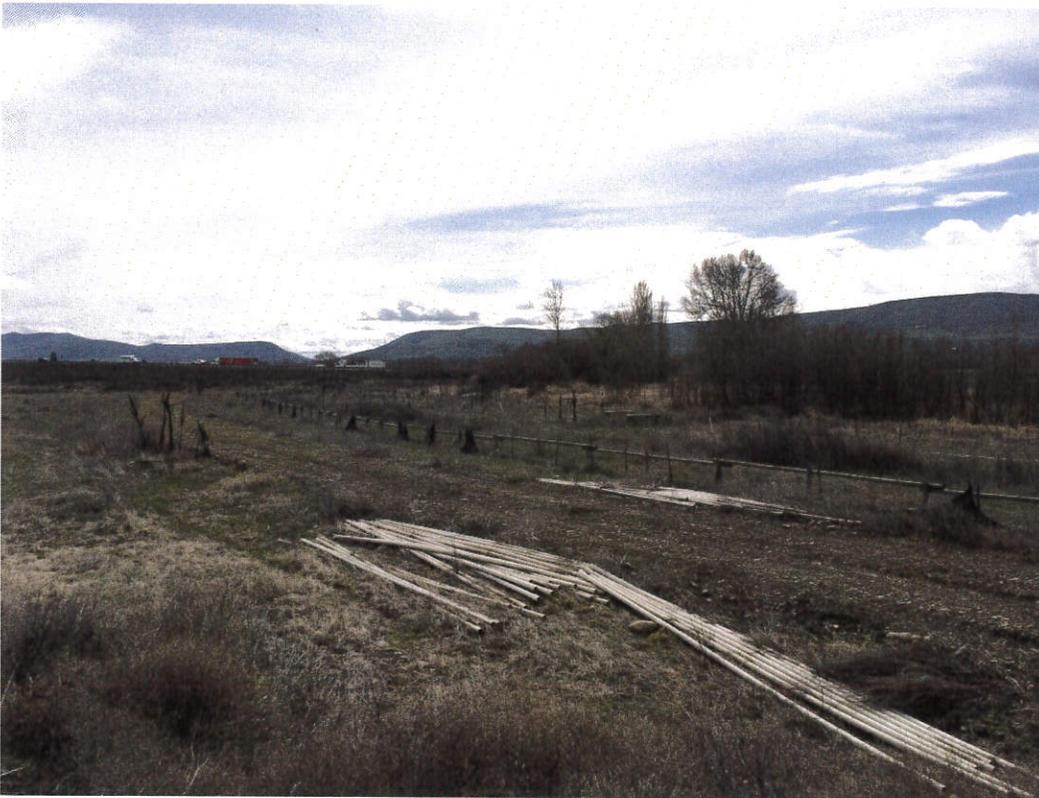
Photo 8. Land adjacent to riparian area, looking south to freeway. Low wooden fencing indicates approximate border of riparian buffer.

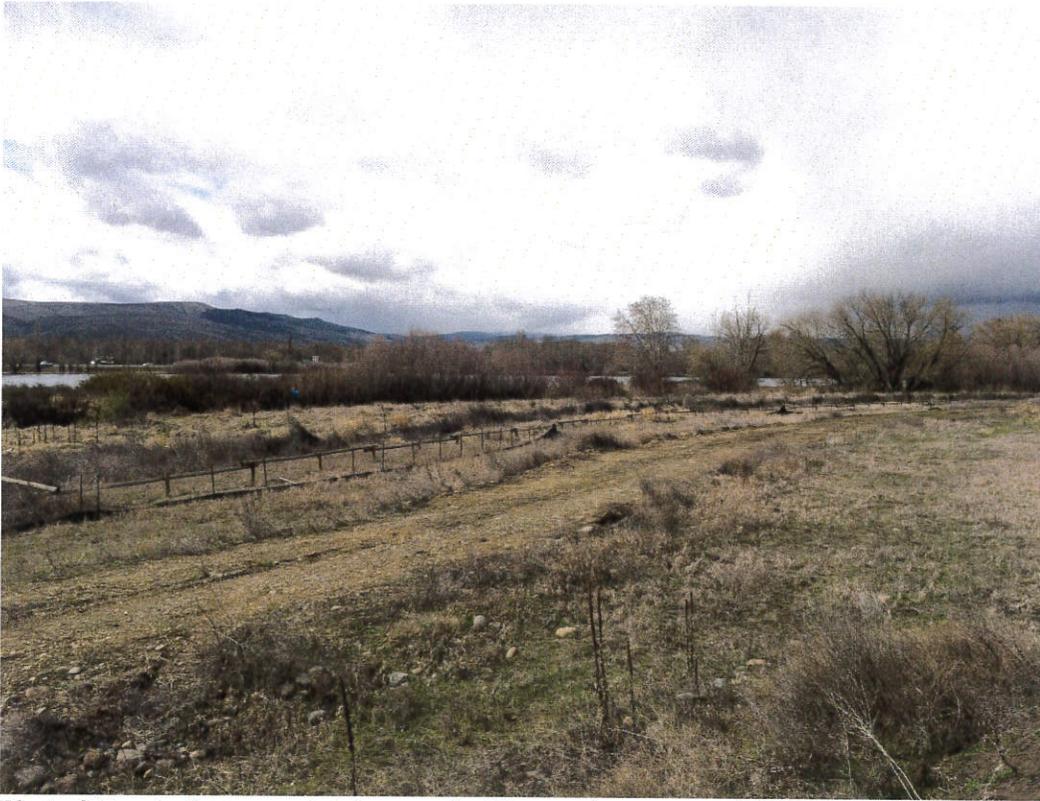
Photo 9. Land adjacent to riparian area, looking northwest towards Mattoon Lake. Low wooden fencing indicates approximate border of riparian buffer.

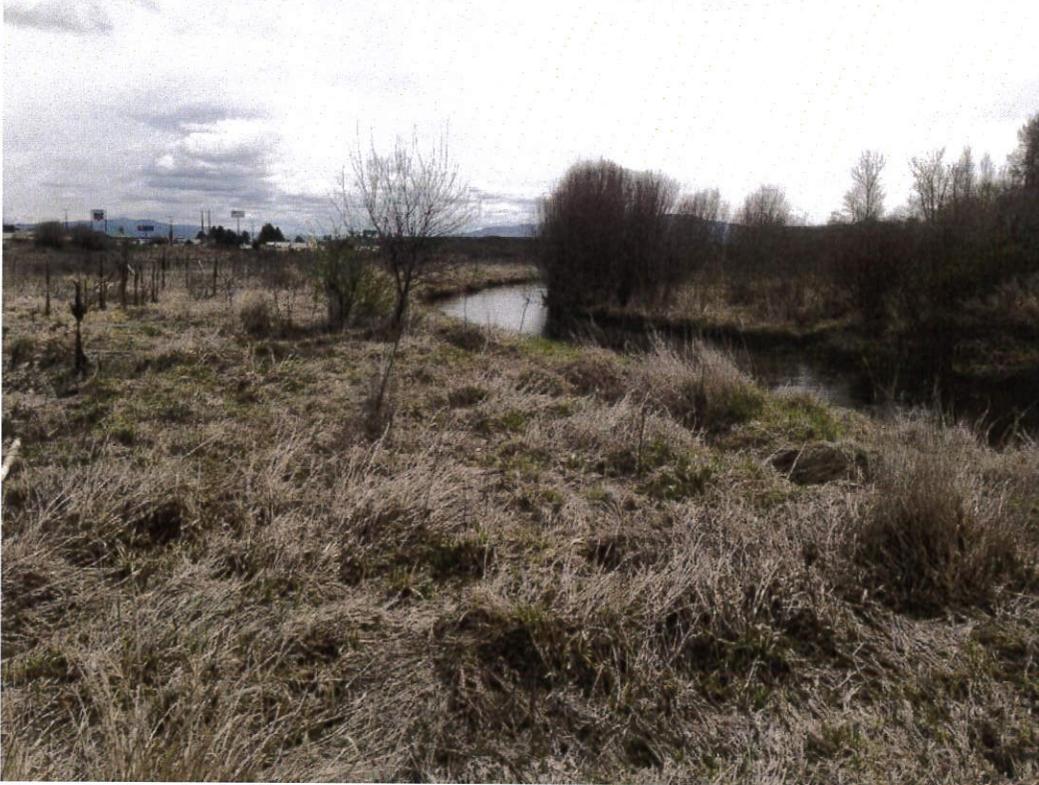
Photo 10. Riparian buffer area along Wilson Creek, looking south, showing reed canarygrass, mullein, and small shrubs/trees on east bank, and coyote willow clumps on west bank.

In the riparian corridor alongside Wilson Creek, the vegetation is dominated by reed canarygrass, with scattered willows (*Salix spp.*), patches of weeds such as diffuse knapweed, tumble mustard, mullein, and common teasel (*Dipsacus fullonum*) (Photos 10 through 15). Native shrubs are present sporadically along the creek banks (Photo 10); most of these on the east side of the creek were planted in 2008 or 2009 during previous restoration efforts, including ponderosa pine (*Pinus ponderosa*) and spruce (*Picea*) saplings, willows, and golden currant (*Ribes aureum*). Several plantings appear to have failed. The opposite, western bank of the creek contains thicker areas of *Ribes aureum*, well-established coyote willow (*Salix exigua*), and a few large willows (Photos 10, 11 and 15).

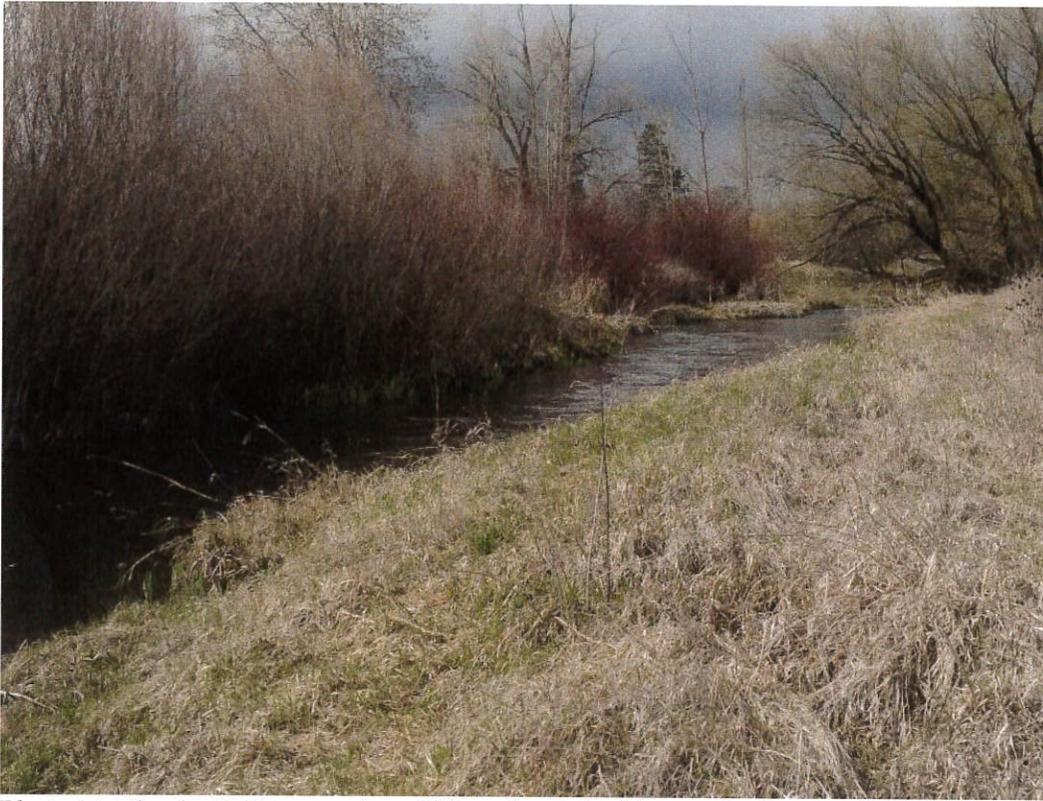
Photo 11. Riparian buffer area along Wilson Creek, looking north, showing dominant reed canarygrass on east bank and coyote willows on west bank.

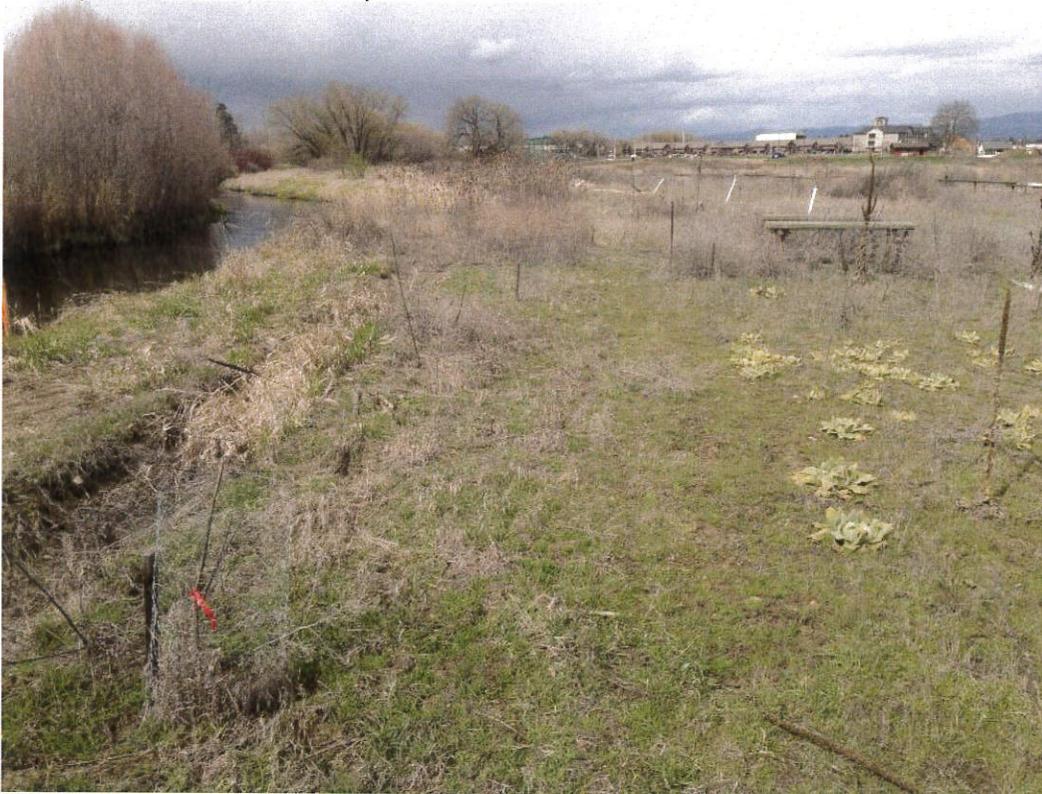
Photo 12. Riparian area along Wilson Creek looking north, showing mitigation plantings (foreground, protected by mesh), low grasses (foreground), and mullein, tumble mustard, and teasel

(background).

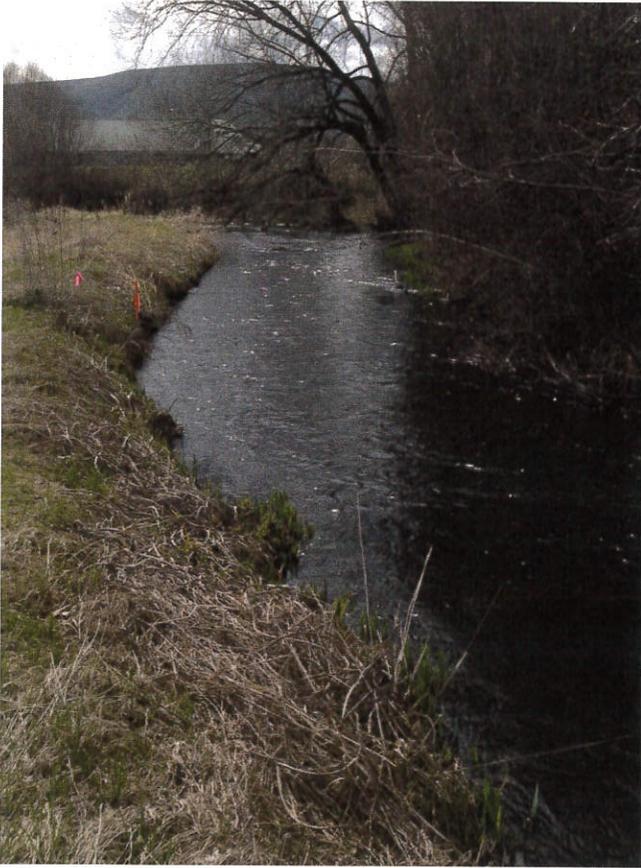
Photo 15. Banks of Wilson Creek on southwest corner of property, showing coyote and Pacific willow on west bank, reed canarygrass on east bank, and yellow flag iris sprouting along waterline.

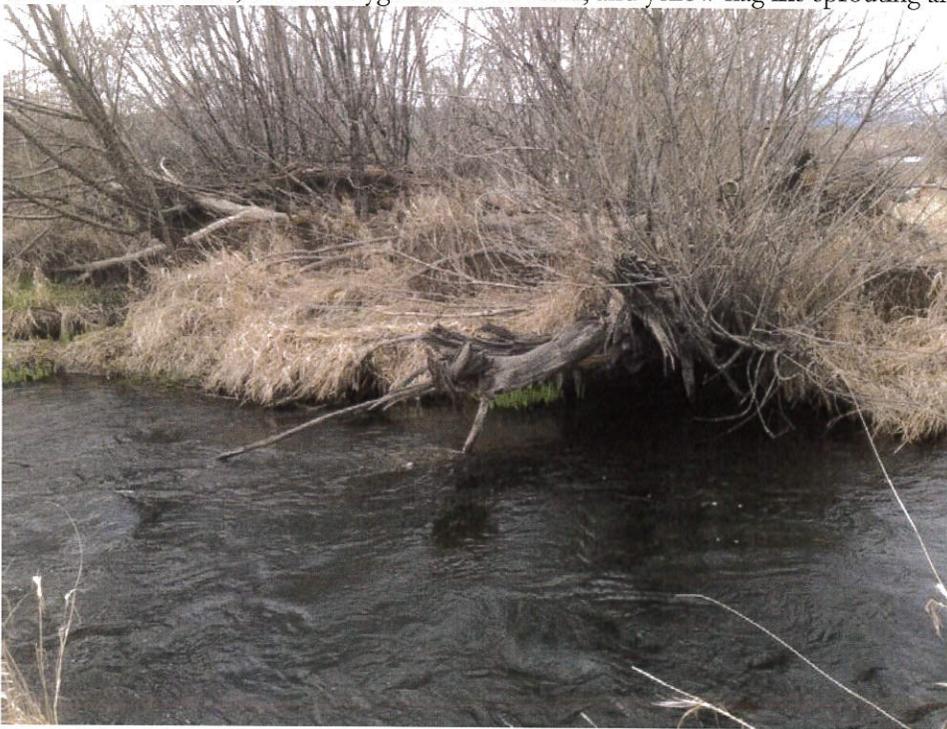
Photo 16. Woody debris on west bank of Wilson Creek.
